# AQUA REX<sup>TM</sup>

## SOFTENER ALTERNATIVE NOW IN USA

# CLEANS UP AT THE GYM

**Trial of an Aqua-Rex WK1 Physical Water Conditioner at Premier Fitness, 3918 Campus Dr, Newport Beach, CA between 1<sup>st</sup> October 2009 and 7<sup>th</sup> November 2009.**

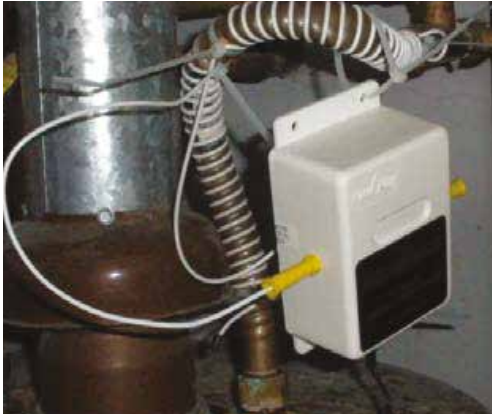
An Aqua-Rex WK1 unit was installed on the flexible cold water connection to the tank water heater and plugged into a nearby outlet. The signal generated by the unit travels into the water heater and also travels back against the flow to treat all the cold water in the property.

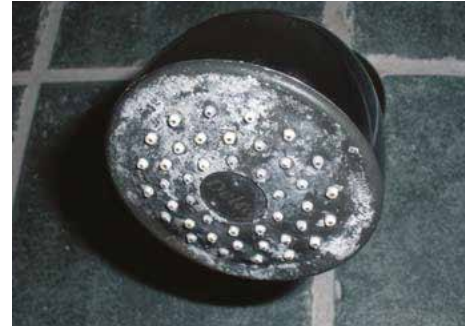
At top is a photo of the showerhead in the left hand cubicle of the women's changing room on 1<sup>st</sup> October 2009. This was the date the Aqua-Rex WK1 unit was installed on the cold water inlet to the tank water heater. The scale on the showerhead was hard and encrusted and could not be removed by wiping or rubbing.

Showerhead in the left hand cubicle of the women's changing room on 1<sup>st</sup> October 2009.

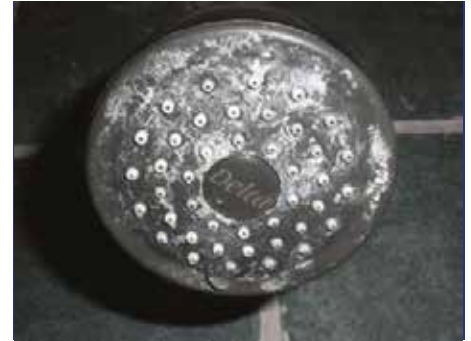
The middle photo is the same showerhead on 7<sup>th</sup> November 2009, just over five weeks after installation of the Aqua-Rex unit. The original scale remains on the showerhead but no additional scale has been deposited. The difference is the quality of the scale. It is now soft and can be wiped off with the hand leaving the showerhead almost completely clean as shown in the bottom picture. The Aqua-Rex unit has softened the scale and reduced its adhesion to the shower surface. It has also stopped new scale from forming.

Same showerhead on 7<sup>th</sup> November 2009 before any cleaning.

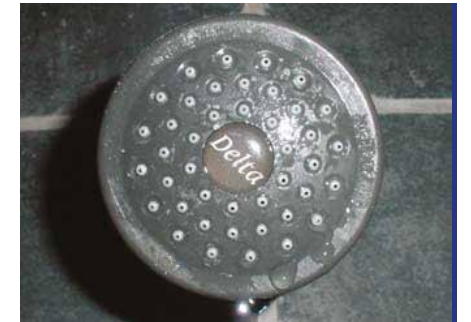
Same showerhead on 7<sup>th</sup> November 2009 after wiping with hand.

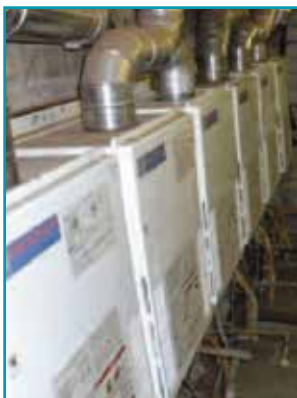
Hot Water to a four star Laguna Beach Hotel was provided by a bank of seven tankless water heaters. Over a number of years the hotel had suffered from a succession of heater failures due to scaling. An Aqua-Rex WK3 unit was installed on the 2" cold line to the water heaters on 1<sup>st</sup> December 2008.

On 30<sup>th</sup> January 2009 one of the heaters was removed for inspection. The heat exchanger was found to be completely clear of scale. Previous experience suggested that it would have been heavily scaled.

The hotel management also reported much better pressure in the hot water system. The showerheads require less cleaning and there have been no heater failures due to scale in the heat exchangers since the Aqua-Rex installation.

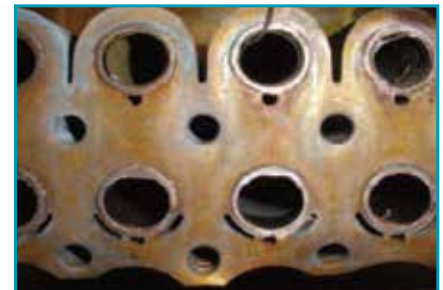
Scaling of butterfly valves and check valves is a common problem in Las Vegas. On March 31<sup>st</sup> 2009 this valve from the hot water line in a Luxury Las Vegas Hotel was installed on a cold water supply line downstream from an Aqua-Rex WK3.

On June 8<sup>th</sup> 2009 the valve was removed for inspection. Most of the scale had disappeared and almost all the remaining scale fell out. The valve was fully operable again.

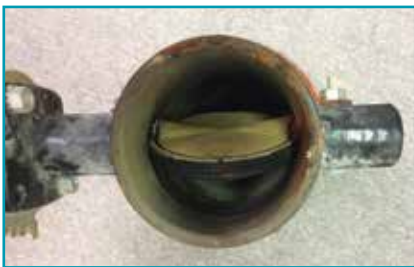
In December 2014 about a dozen similar valves were removed for inspection. None of them had any significant scale in them, thus showing how effective the Aqua-Rex had been in de-scaling the system. No adverse events had occurred as a result of the scale being removed.

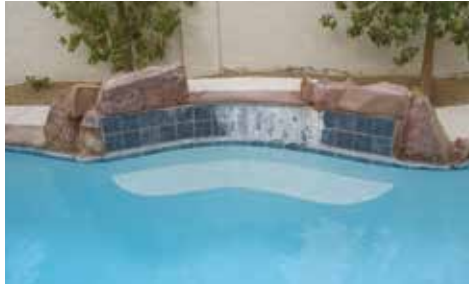
This swimming pool in Las Vegas NV suffered badly from scale along the water line and down the spillway. Phosphates were always high, affecting the clarity, and TDS was off the scale of the measuring instrument.

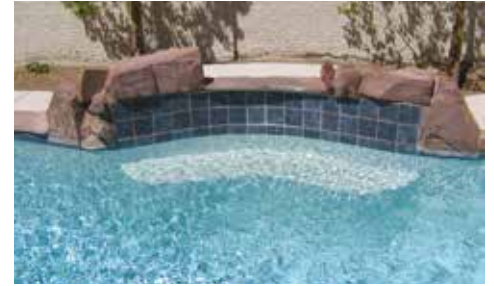
scale had fallen off the tile walls and could be vacuumed up from the bottom of the pool. The remaining scale on the tiles could be wiped away. A second photo of the pool was taken in August 2010 and shows the tile walls still clear although there was still some scale remaining on the rock surfaces. The pool water is much clearer showing a substantial reduction in phosphates.

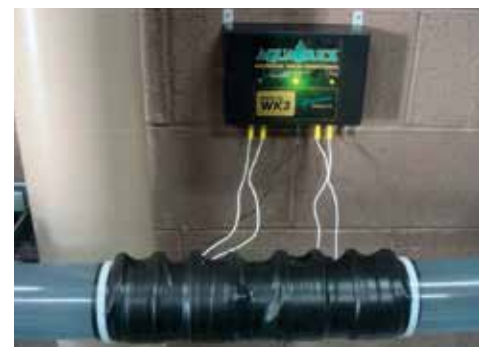
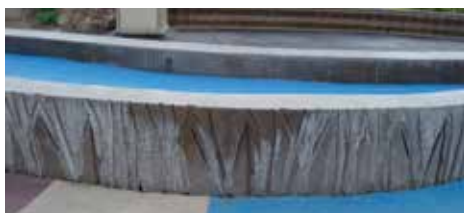
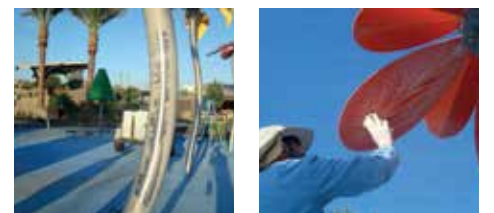
This recreational play park in the City of Henderson NV suffered very badly from scale on all wetted surfaces. It required regular chemical cleaning to remove encrusted scale from the supply pipes and features.

An Aqua-Rex WK3, commercial unit, was fitted on the supply line to the Splash Pad on August 15<sup>th</sup> 2013. Just 48 hours after installation scale could be wiped from the petals of one of the flower features with minimal effort and no chemicals. By August 21<sup>st</sup> 2013 it

was possible to clean this vertical supply pipe with a pressure washer. Even the concrete outer wall of the lazy river could be cleaned with a pressure washer.
